REEF BAY GREAT HOUSE

By Frederik Gjessing

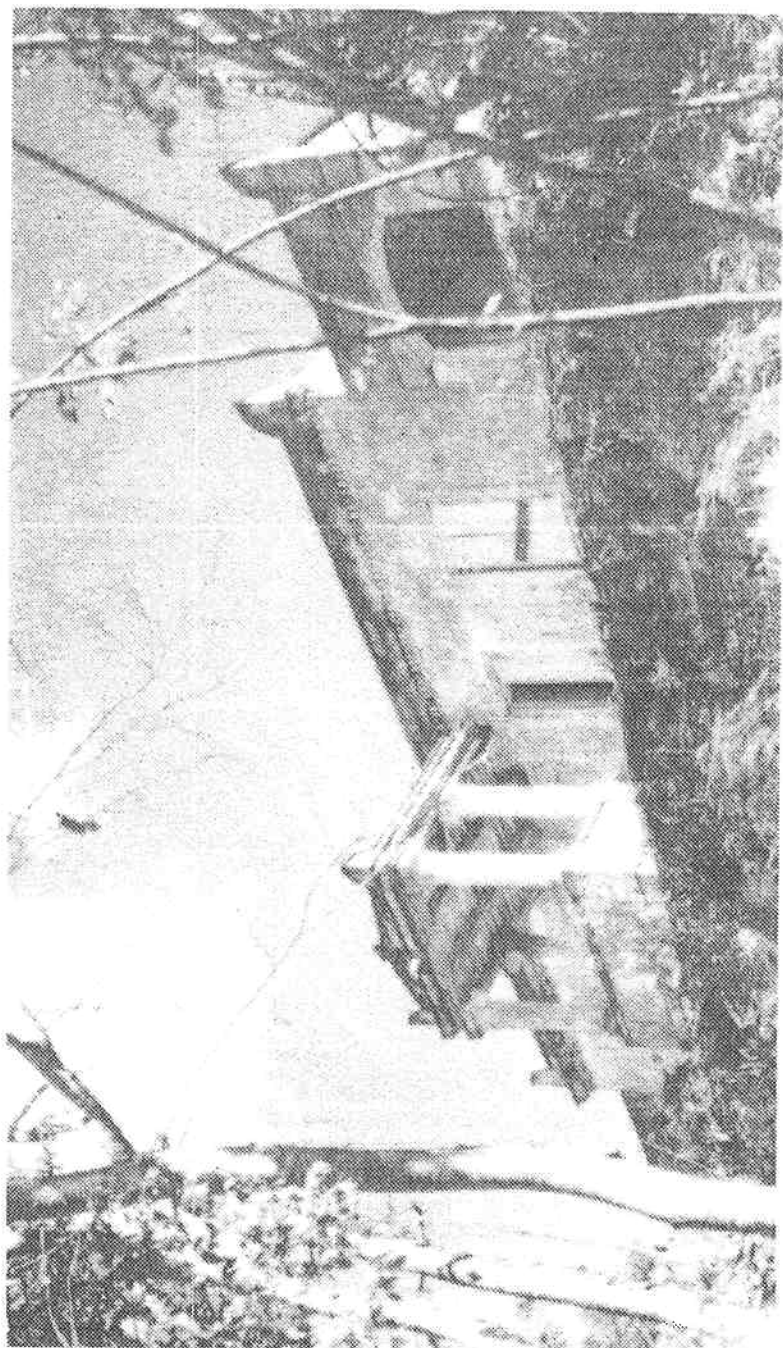
Historic American Buildings Survey Photo

The Great House viewed from the southwest. The staircase leading up to the front porch and the basement story is hidden by the retaining wall of the front terrace. Note the tracing of the stucco banding and the retaining wall (foreground) and the architectural treatment of the galley and the porch.

The yard south of the building continues behind the building and was apparently intended to be approximately 7 feet above the front terrace. It is narrow and irregular in shape and bounded to the east by the steep hillside and exposed rock ledges. Immediately behind the house a 3' retaining wall parallel with the building and 16' from it gave definition to the rear yard. Steps in the northeast corner led down to the area north of the Great House and provided easy access to the stable and outbuilding to the east from the rear entrance of the building. The retaining walls and staircases, where they are still standing, have the same stucco band decoration as observed on the buildings.
